Don't Leave it to Beaver: Comprehensive Pond Restoration in the Face of Wildlife-enhanced Stormwater Impacts

MA COLAP Annual Workshop
Westboro, Massachusetts

April 12, 2019

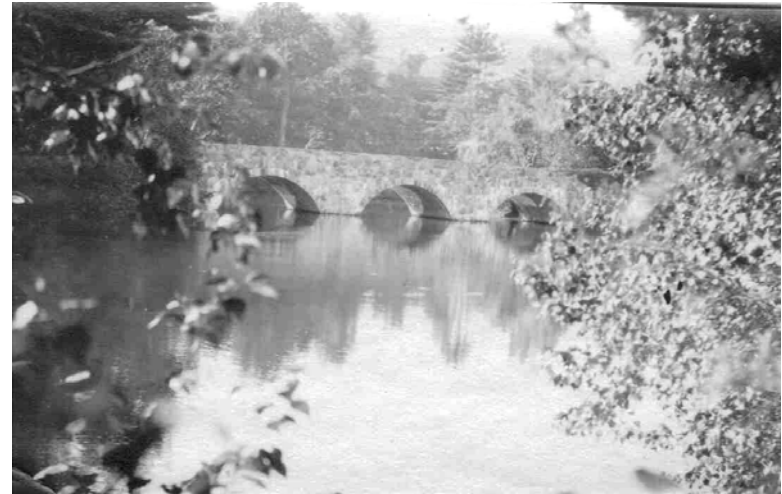
- Flowering Pond - Origins
 - Originally the Moseley family's private estate pond in Newburyport, MA
 - Impounded in a narrow, sheltered valley
 - Tiny – approximately 2.0 acres
 - Surrounded by gardens and rural matrix of fields, forest, and wetlands
 - Crossed by bridge, which became a iconic spot for photographs

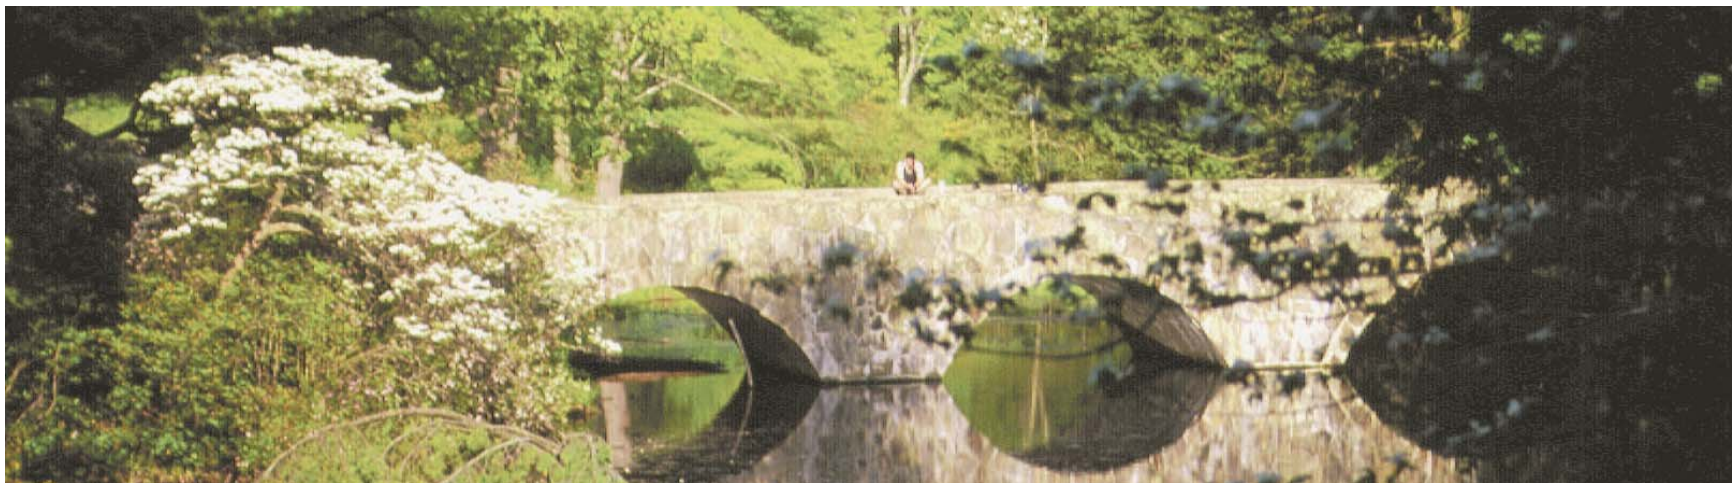
- Flowering Pond - Maudslay State Park
 - Became state park in 1985
 - Due to erosion/sedimentation over time, pond filled in, restricting water flow under the historic bridge
 - DCR and Maudslay State Park Association desired to bring back the open waters of Flowering Pond for passive recreation, aesthetics, and ecological restoration
 - Restoration process started with assessment of the pond and development of a lake management plan in 2012

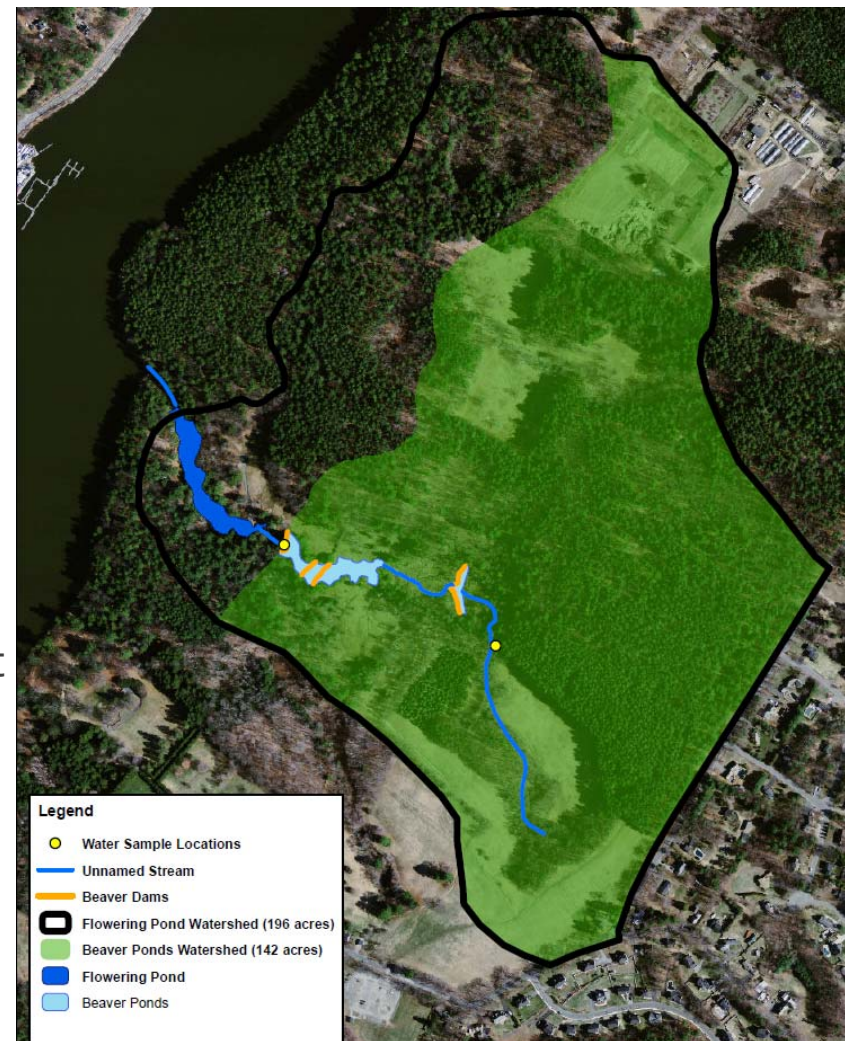
The Setting

- Flowering Pond watershed
 - Small by absolute standards – just 186 acres – but somewhat large relative to pond
 - Almost entirely within state park boundaries
 - Watershed primarily forest and fields
 - Very little impervious surface
 - However, multiple beaver dams present upstream of Flowering Pond

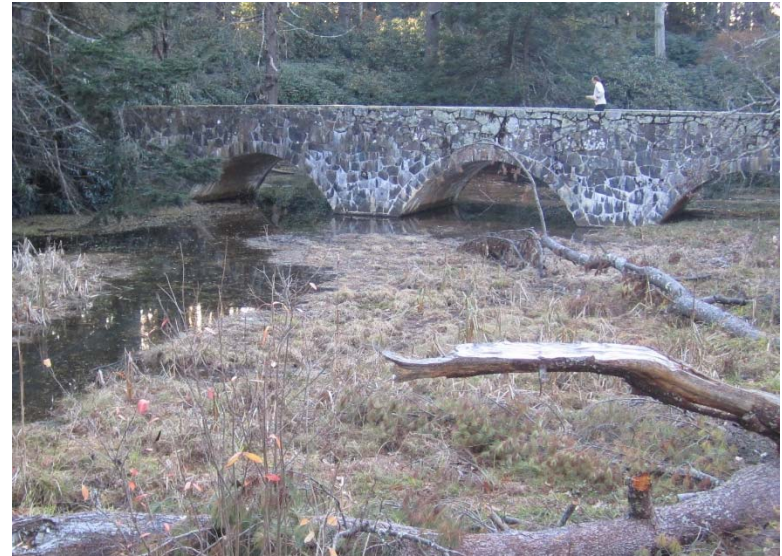
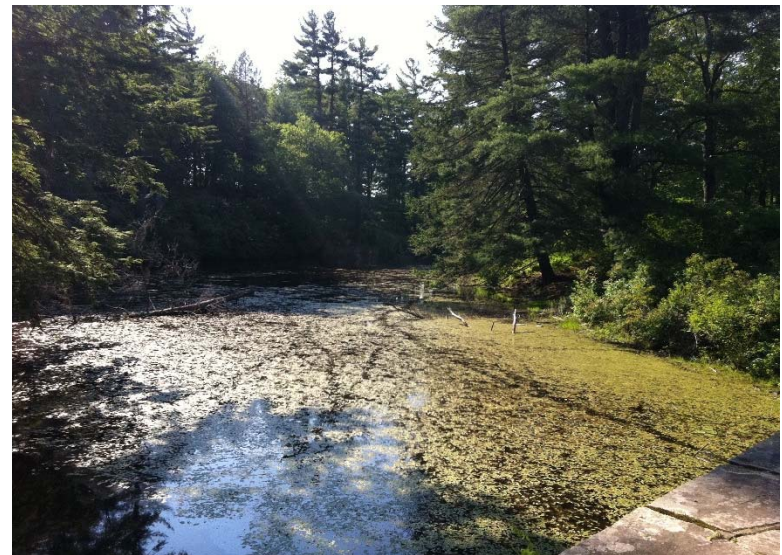
The Issues: Part One

- Excessive sedimentation
 - Extensive deposits of sediments, most notably on upstream side of bridge
 - Water no longer flowed under all three arches of the bridge
- Nuisance aquatic vegetation
 - Excessive duckweed, rooted plant growth, and algae imparted a lawnlike look to Flowering Pond for much of the growing season

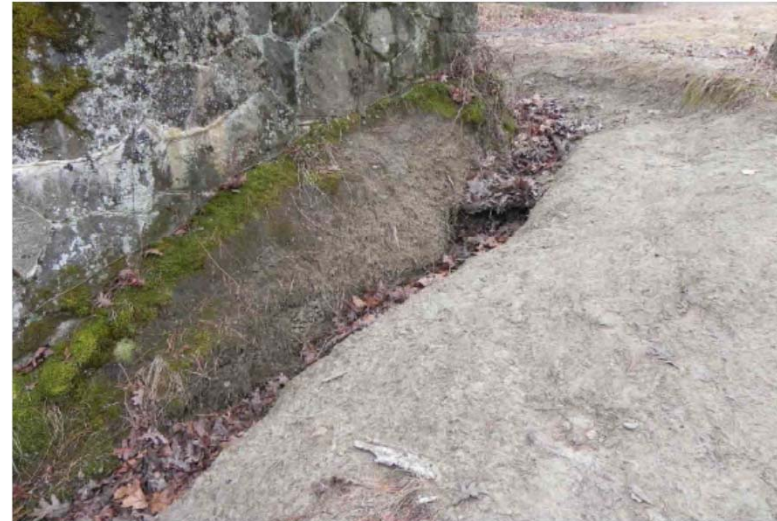
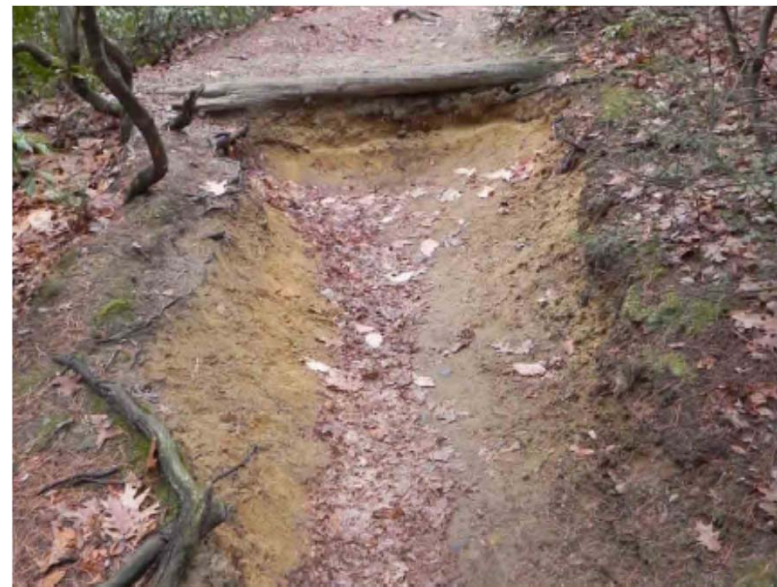
The Issues: Part Two

- Stormwater Runoff
 - Watershed almost entirely within park with minimal impervious area but stormwater still a problem
 - Stormwater issues occurred where road and trail system funneled runoff into pond
 - People and wildlife reinforce by following these channels as preferential pathways between pond and upland

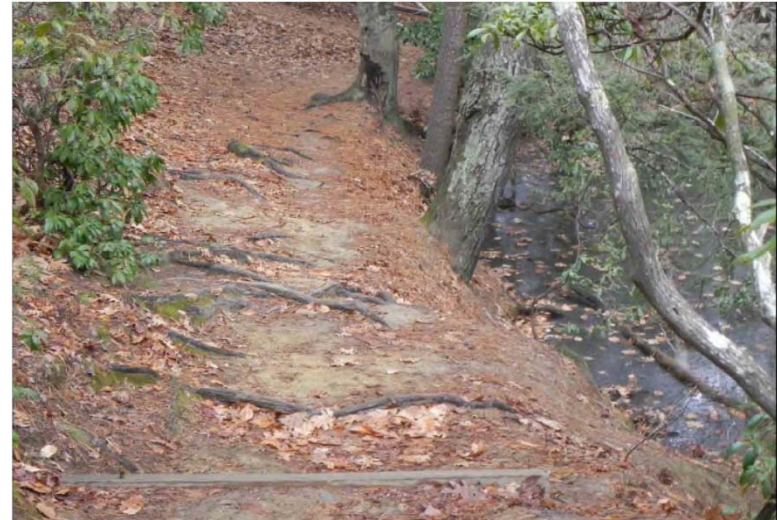
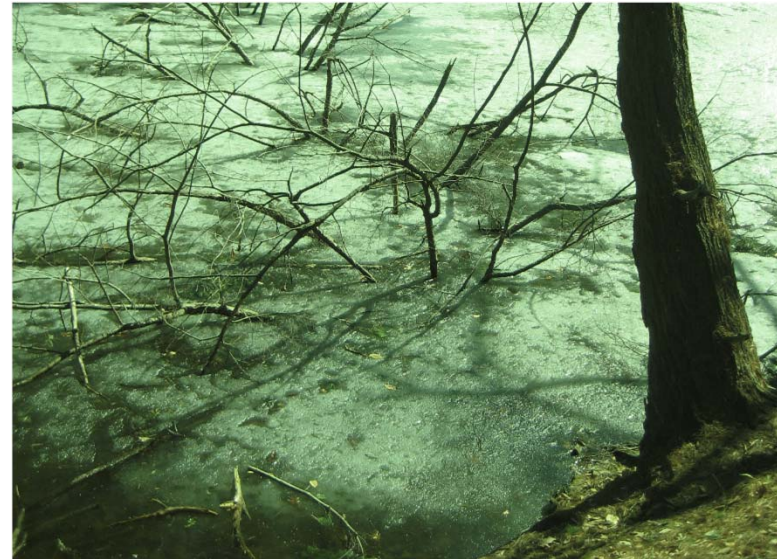
The Issues: Part Three

- Shoreline Erosion
 - Felled (by beavers)/fallen trees destabilized bank along the shoreline
 - Pond loop trail was sloped toward pond and eroded
 - Steep slopes down to pond

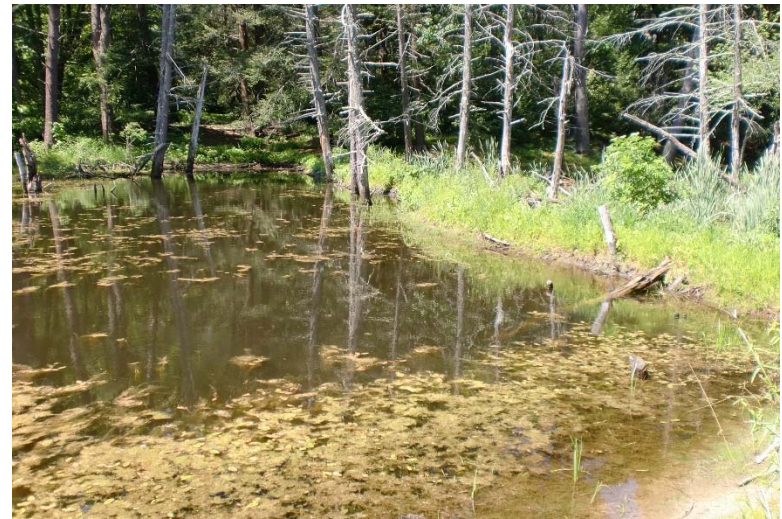
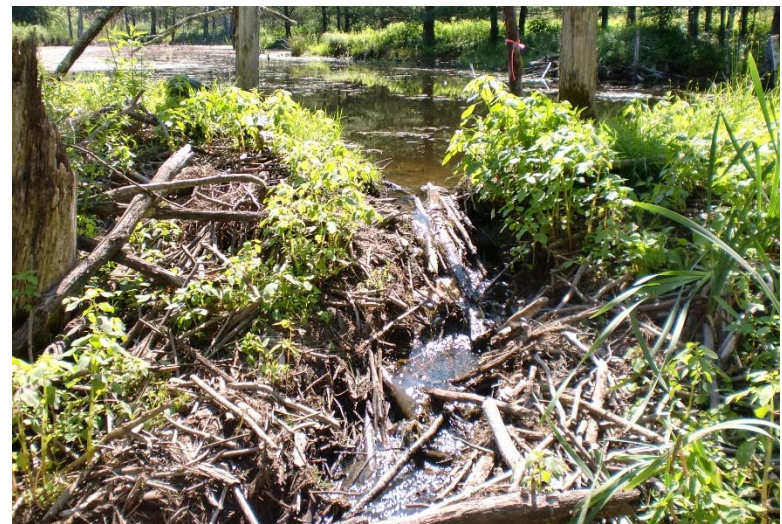
The Issues: Part Four

- Series of several beaver dams up to 4' high upstream of the pond
 - Source of nutrients to downstream waters - phosphorus in outlet from beaver ponds was more than that at twice inlet
 - Increased temperature and reduced dissolved oxygen of flow to pond
 - Potential public safety issue
 - Uncontrolled release of sediments would quickly refill restored pond
 - All of these impacts magnified by the large size of the beaver ponds relative to Flowering Pond – might not be a problem for a larger receiving water

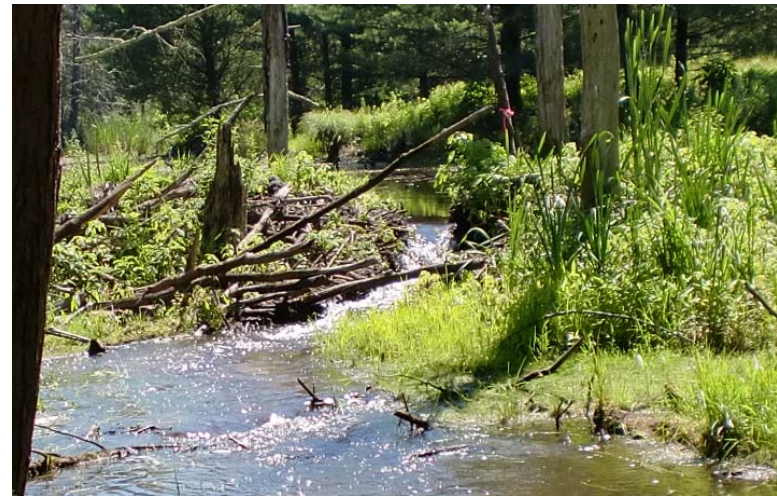
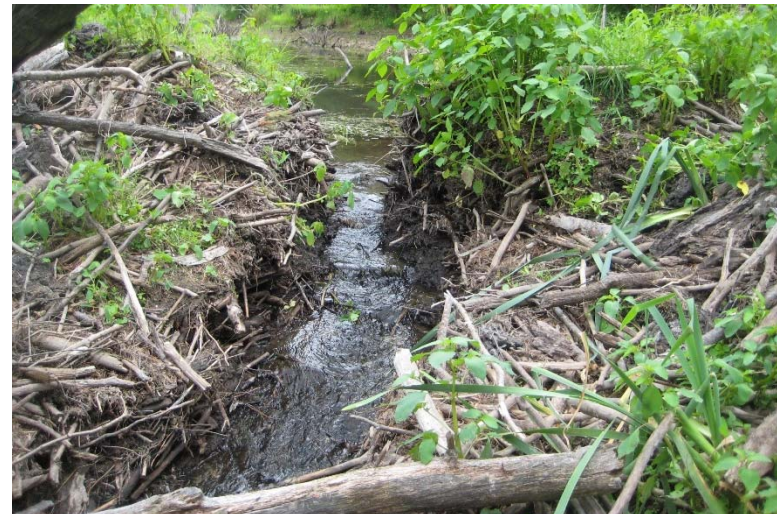
The Plan: Step 1, Year 1

- Start with the Beavers
 - Ignoring or delaying this step could truncate lifespan of restoration project
 - Trap and remove remaining beavers
 - Breach the beaver dams
 - Start downstream and work way up
 - Work gradually, over several days for tallest dam
 - Allow water to drain slowly to keep discharge in check and minimize mobilization of sediment
 - Added selective tree removal to prevent shoreline destabilization due to treefall
 - Completed in 2013

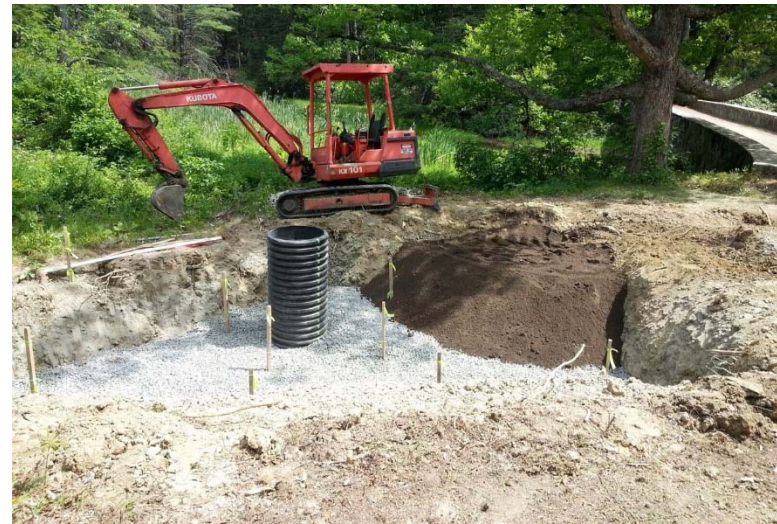
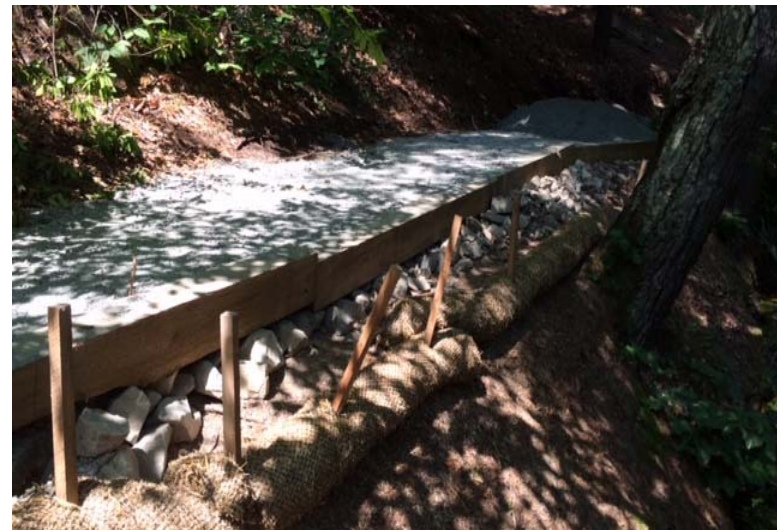
The Plan: Step 2, Year 2

- Address Stormwater & Erosion
 - Installed two rain gardens to capture stormwater runoff from park road and steep trail run
 - Loamed, stabilized, and replanted slopes near bridge
 - Revegetation with a mix of native plants and heirloom ornamental shrubs
 - Graded shoreline trails, backfill with gravel, and retain with anchored timbers on pond side
 - Completed in 2014

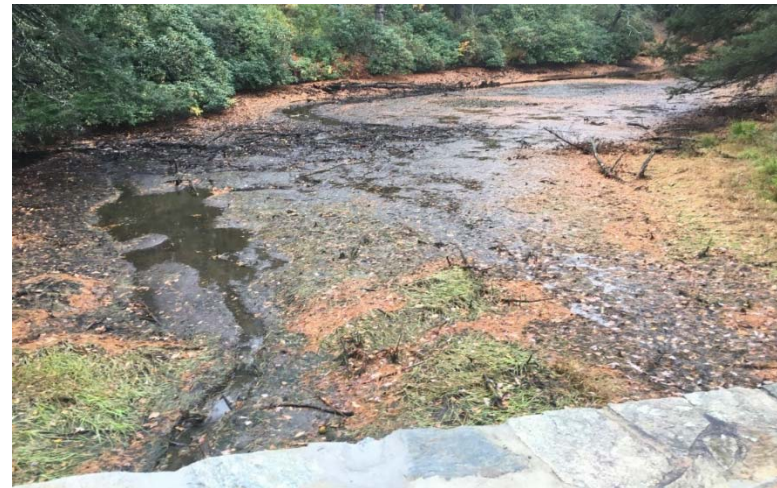
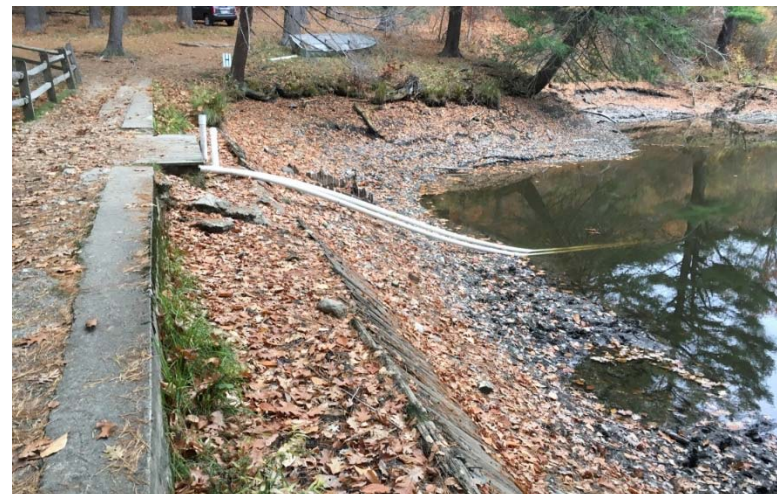
The Plan: Step 3, Years 3, 4, and 5

- Dredge the Pond
 - Complex permitting – local, state, and federal permits/approvals needed
 - Dredging “in the dry”
 - Drew water down in the fall to prepare
 - No discharge control so water pumped over spillway
 - Kept fingers crossed for cold winter...

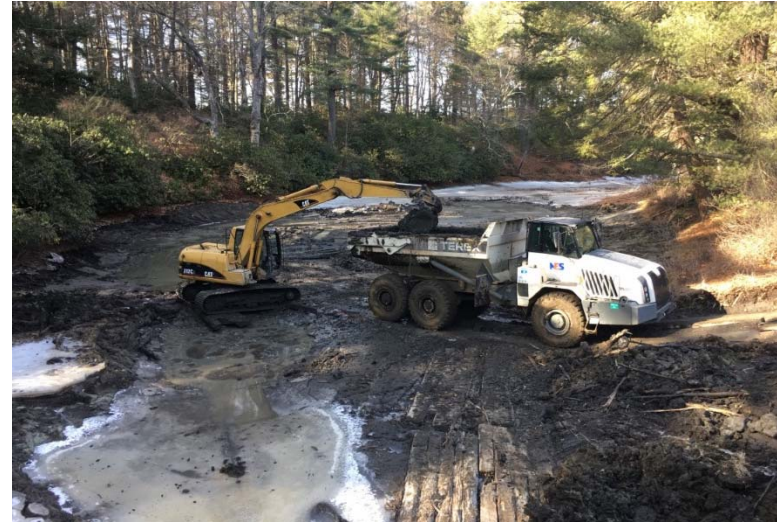
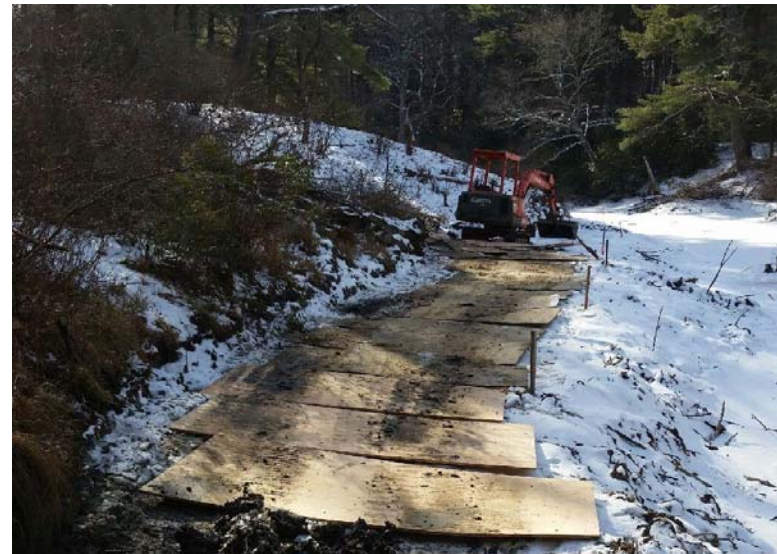
The Plan: Step 3, Years 3, 4, and 5

- Dredge the Pond
 - Ended up with fifth warmest winter on record
 - Eventually, with persistence, ingenuity, and few days of colder weather, dredging was completed in 2017
 - Focused dredging on southern end of the pond, nearest the bridge to remove accumulated sediments
 - Constructed a shallow wetland bench near the northern end of the pond to enhance shoreline habitat
 - Overall, removed ~1,500 cubic yards

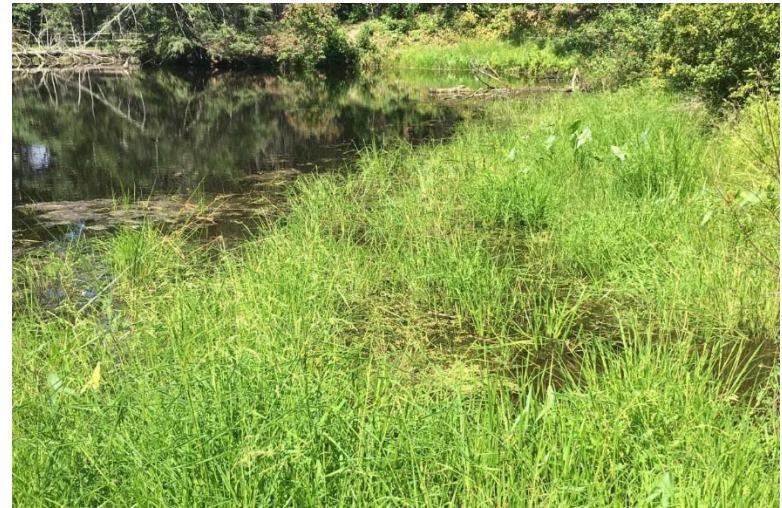
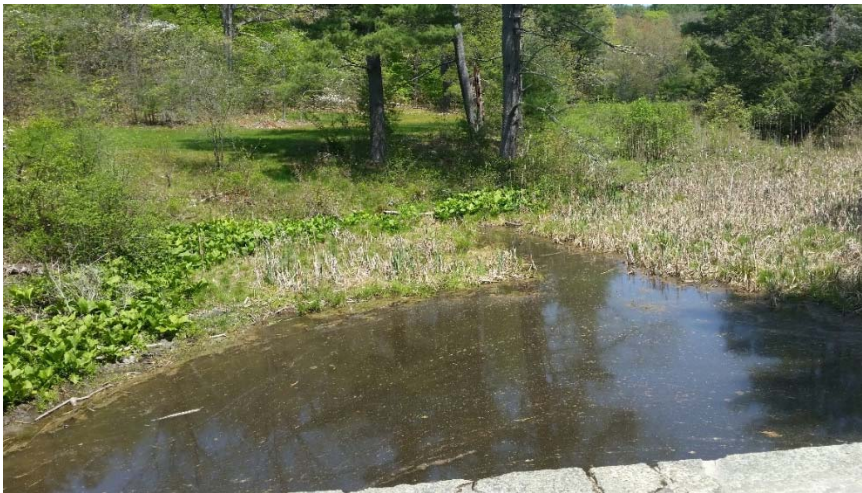
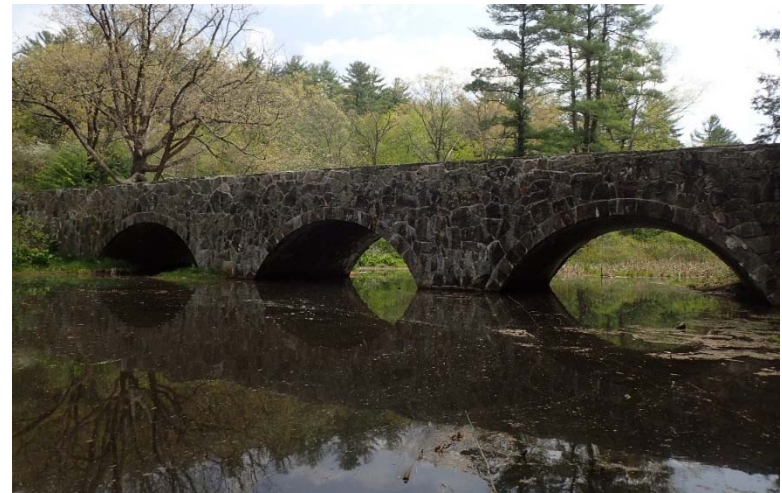
The Results So Far

- Pond once again extends upstream of bridge
- New wetland bench stable and growing in
- Beavers kept at bay
- Monitoring continues
